Case Study #30: Concrete Concrete storage silos

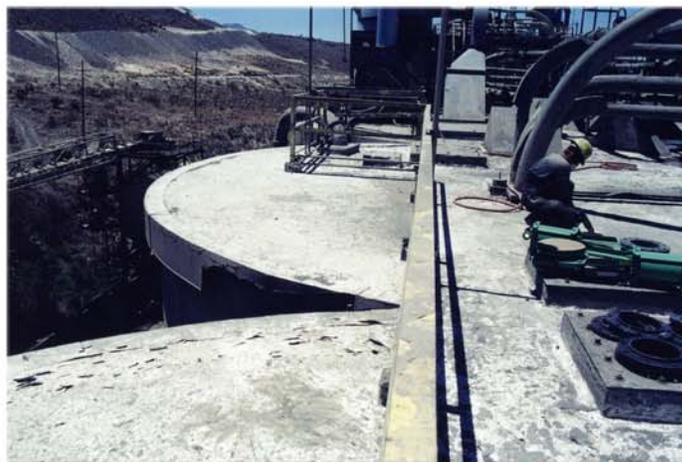
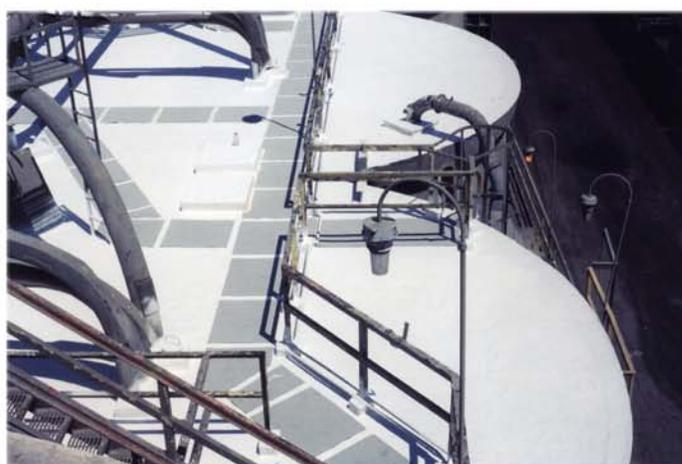
Mitsubishi Mining Company in Lucerne Valley California had a big problem. The storage silos for their finished cement products had leaks. Water seepage into almost any material is not good especially cement storage silos. The leaking water made the powdered cement turn into... concrete.

In one of the storage silos, the leaks were so bad that the lower section of the silo was littered with chunks of dried cement. Upon further investigation, a piece of cement as big as cars was found inside the silo. This piece was so big that dynamite and jackhammers had to be used inside the silo to break it down into smaller pieces before they could be removed.

The system used was the Energy Seal Coatings full fabric system. This system was applied on top of a cured, rubberized emulsion. As an added safeguard, after the Acu-Shield acrylic coating dried a coat of Acu-Flex Hydro was applied to protection against future leaks. This roof coating system will reflect up to 90% of the sun's UV rays and protects the silos from the hot desert sun.

Once the roof coating system was complete, a walking deck was installed to allow for high foot traffic and personnel safety.
