# Case Study #65: Transite Transite Roof Maintenance

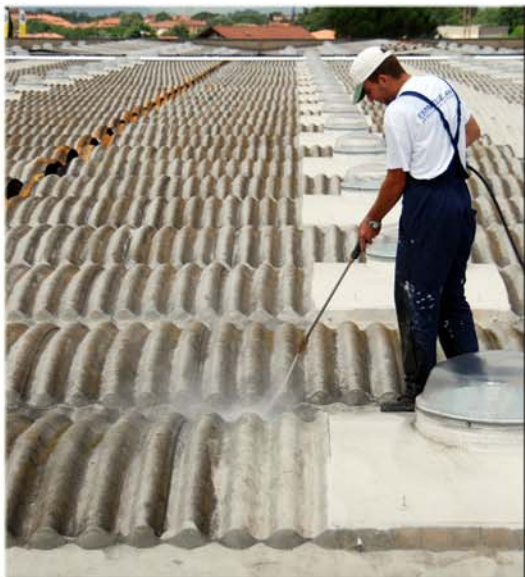
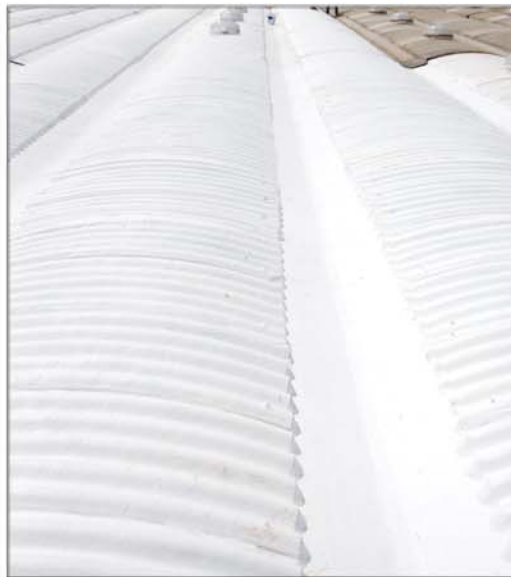
This 65-year-old transite roof was on a manufacturing/ distribution warehouse. The total area of the roof was 320,000 square feet. The building owner was experiencing leaks from the fasteners, mortar joints and skylights. The building owner was also interested in reducing interior temperatures by limiting the heat build up on the roof. The Energy Seal Coatings transite roof system was specified to be installed on the roof.

The contractor pressure washed the roof surface with Acu-Wash. The roof was then primed with Acu-Prime All. Once the Acu-Prime All dried all seams, flashing, fasteners, joints, skylights and damaged mortar joints were sealed with Acu-Caulk. In a few areas, the Acu-Caulk was in conjunction with Acu-Fabric for reinforced repairs. After all detailing was complete; Acu-Shield was applied to the entire roof surface.
