Case Study #11: Metal Building Maintenance Coating

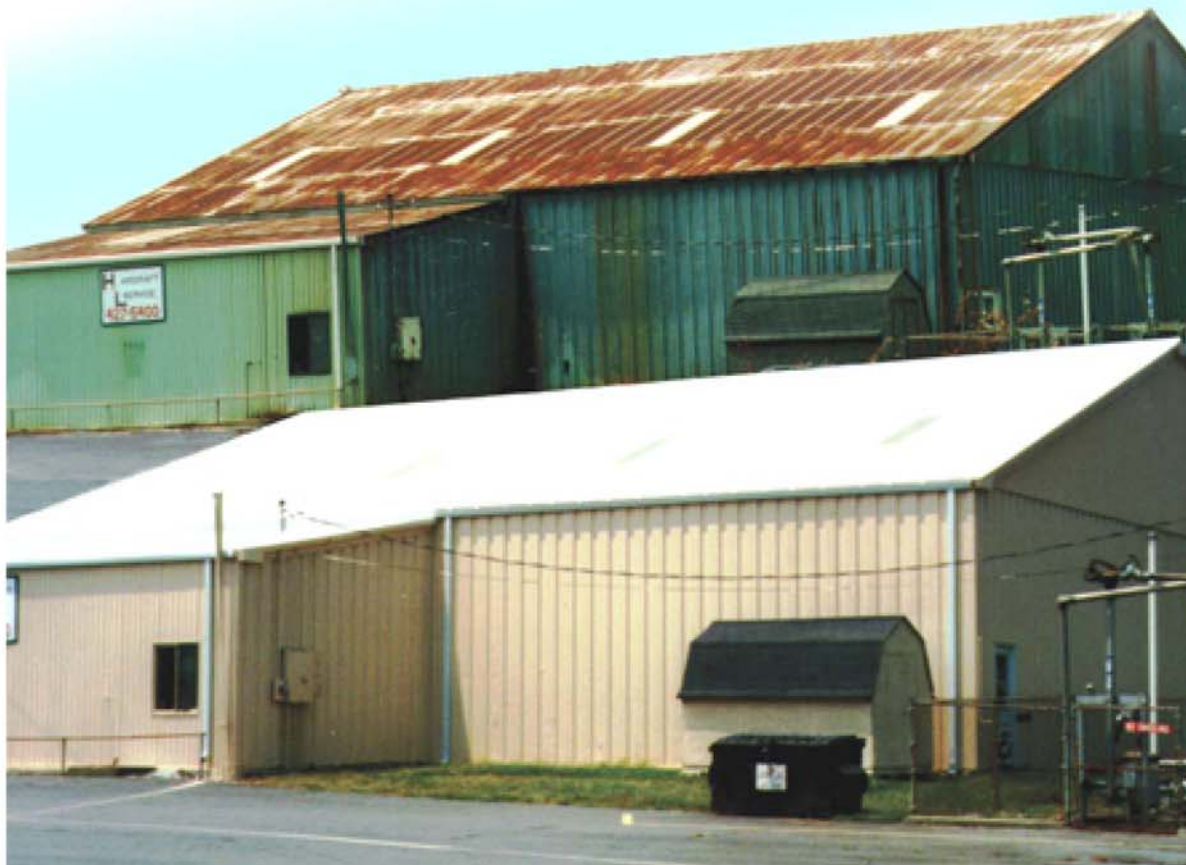
This 35 year old hangar required extensive roof and wall restoration. Roof was 100% rusted and had several holes. Several fasteners had backed out and many seams were pulling apart due to heat related stress. The walls of the hangar were badly rusted and faded.

Our customer says - "It looks brand new." Accelerated aging (caused by heat related stress, rust and leaks) has been stopped. "Interior temperatures have been noticeably reduced". Since then, the customer has coated seven other hangar and support buildings with **Energy Seal Coatings**.

Our acrylic roof and wall coatings are applied as liquid and dry to form a "rubber-like" protective membrane that will make a wall or roof water-proof. They will also **reflect up to 90% of the heat from the sun**. This heat reduction can have a significant affect on lowering interior temperatures of your building, whether they are air-conditioned or not.
