Blowing Hot Air

Reflective Roof Coatings Improve A/C Efficiency

by Alexander Cua - Advanced Coating Systems

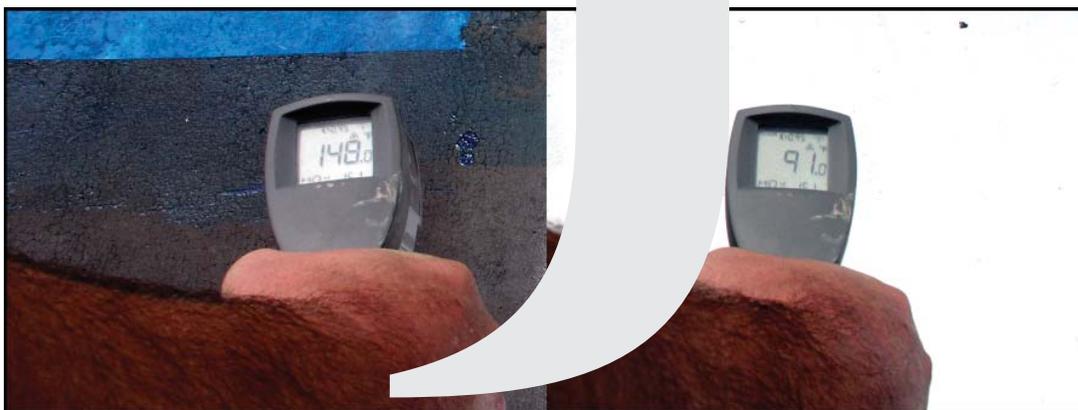
Best Western Inn Roof (Readings taken near A/C above.)

“The uncoated area measured 168.2°F; the coated area was 94.5°F. A heat reduction of 73.7°F or 98%.”

These readings were taken a few days after the roof was coated with Energy Seal reflective roof coatings. There was a significant reduction in roof surface temperatures! The uncoated area measured 168.2°F; the coated area was 94.5°F. It is a heat reduction of 73.7°F or 98%. Even air around the coated and uncoated A/C units had a temperature differential of almost 5°F.
