# Case Study #15: Metal Aluminized Asphalt

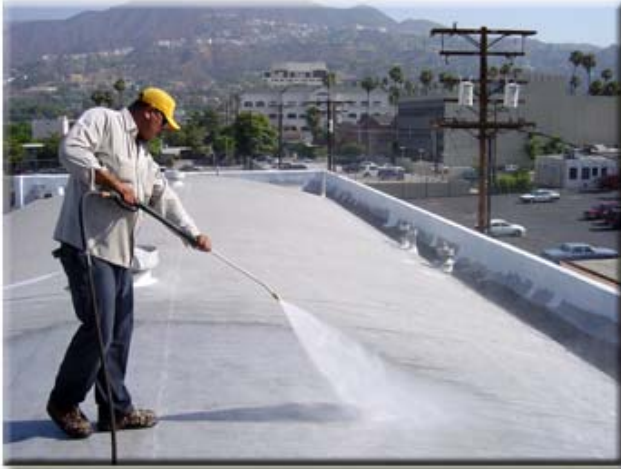
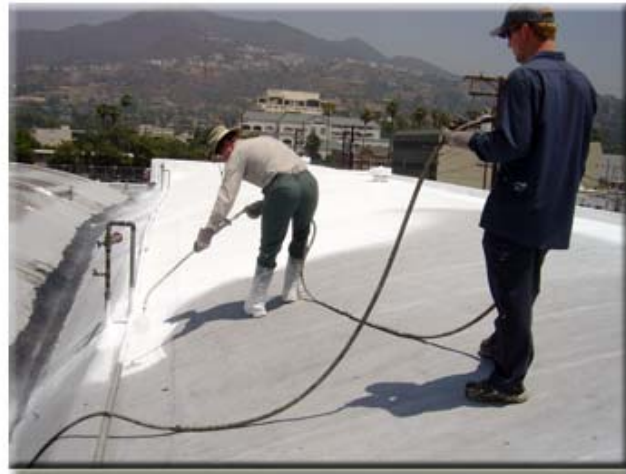
This elementary school was concerned with the condition of their roofs. The roofs were coated with an aluminized asphalt that was getting very close to the end of its useful life. Further concerns were with the roof substrate and its condition. The school was facing the possibility of having to replace the roofs. Upon closer examination, it was discovered that the roofing substrate was in good condition and did not have to be replaced. The decision was then made to apply the Energy Seal Coatings roof coating system to extend the life expectancy of the roofs.

After a few minor repairs were made and the roof was pressure washed it was ready for the roof coating system. All vents, flashing and penetrations were primed and sealed with Acu-Caulk. The roof surface was primed using Acu-Prime All. Once the Acu-Prime All was dry Acu-Shield was applied in three separate coats.
