## **Ceramic Coatings / Elastomeric Coatings**

### **Ceramic Coatings Installed on Federal Buildings at Tyndall Air Force Base**

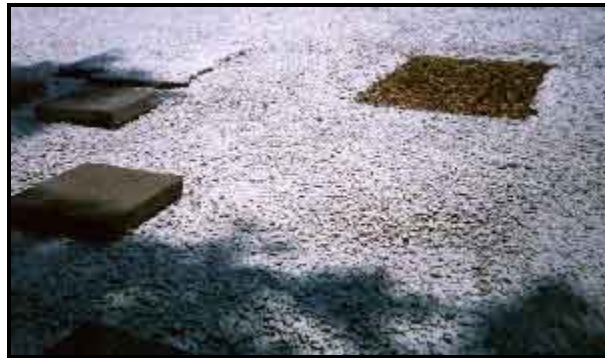
Figure 1. Uncoated patch (upper right) and coated piece (upper left) for solar reflectance samples at Tyndall Air Force Base

The solar reflectances of the radiation control coatings decreased as the coatings weathered. Laboratory techniques were relied upon to measure the changing solar spectrum reflectances. Samples of roofs covered by weathered coatings were removed periodically from the roofs and brought to the laboratory. Extra pieces of roof membranes were coated along with the roofs at Tyndall AFB and placed on the roofs to provide these samples (see Figure 1)

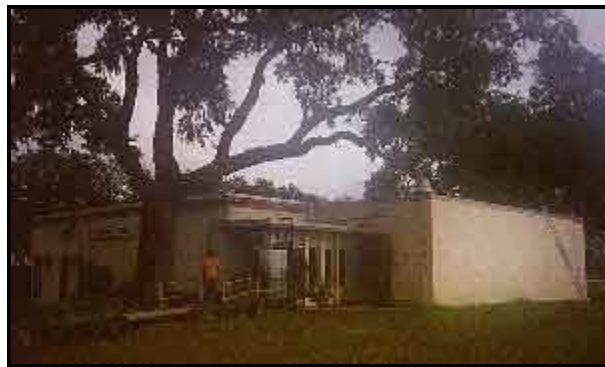
Figure 2. Convenience store at Tyndall Air Force Base.

Two other buildings at Tyndall AFB, a veterinary clinic and a convenience store, were selected to have their entire roofs covered with the ceramic coating (see Figure 2). These buildings had built-up roofs with gravel imbedded in the bituminous topping. The coating was applied to the rough-surfaced roofs with an airless sprayer. To monitor the expected energy savings, pulse-initiating kilowatt-hour electrical meters were installed in both all-electric buildings. The veterinary clinic is a small building with a moderately well-insulated roof; it has a weekday-only operating schedule and little internal load. It is heated and cooled by an electric heat pump. The convenience store is a medium-sized building with a moderately well-insulated roof. Its load characteristics are a 7-day per week schedule and heavy internal load from refrigerators and freezers. The veterinary clinic and convenience store are similar in architecture; both have stucco-covered cement block walls and built-up low-slope roofs. Large trees shade the convenience store, and this shading proved to be a significant variable in the analysis of the coatings' performance.

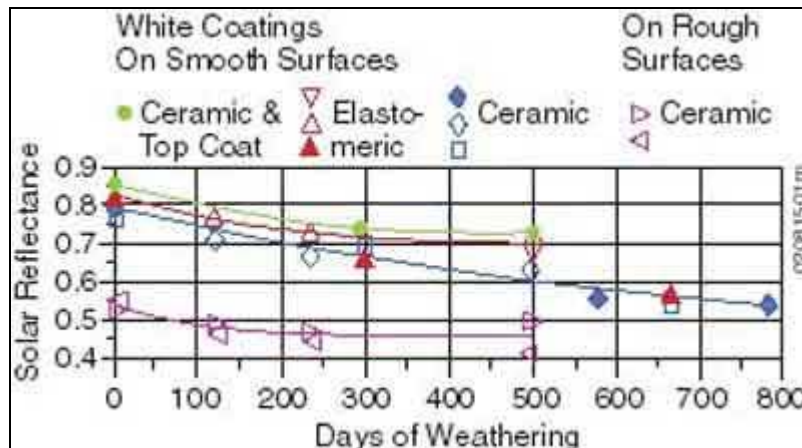
Figure 3. Behavior of the solar reflectance of various white coatings on smooth and rough surfaces as the coatings weather.

Measured solar reflectances for the ceramic coating as installed on the two rough-surfaced built-up roofs (BURs) were 0.52 and 0.54, respectively, or about 0.53. Relative to the 0.09 reflectance of the uncoated BUR, these reflectances produce a significant decrease in solar radiation absorbed, from 1-0.09 or 0.91 of the incoming solar radiation, to 1-0.53 or 0.47. The solar reflectance of 0.53 is at least 0.2 lower than we have observed for similar fresh white coatings on smooth, low-sloped surfaces. On the smooth-surfaced fast food restaurant roof at Tyndall AFB, the ceramic coating and an acrylic elastomeric had initial reflectances of 0.76 and 0.80, respectively. The same acrylic elastomeric and a different ceramic coating at our roof test facilities in East Tennessee showed initial reflectances of 0.81 and 0.85, respectively.

Over the course of the project, from July 1996 through October 1997, the reflectance for the shaded rough BUR on the convenience store decreased to 0.42 while the coated roof reflectance at the veterinary clinic decreased to 0.50. On smooth, low-slope surfaces after several years of weathering we have observed values as low as 0.50 to 0.55.
